Re: Roxborough - Chatfield Farms Park Safety Survey

## Report Summary

Report Name: Roxborough - Chatfield Farms Park  
Completed for: Roxborough Village Metro  
Inspection Date: March 15, 2022  
Score: 61.9%

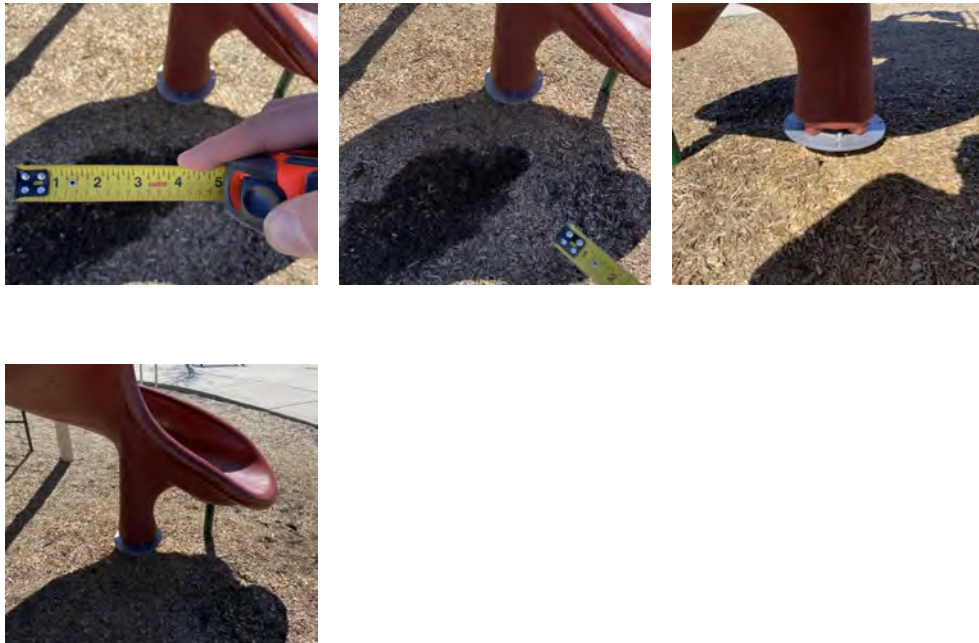
**Issue Identified** **Protective surfacing under and around the equipment is not adequate**  
**Recommendation** *Install/replace surfacing materials. [reference ASTM I 1487, CPSC] [View ASTM Site](#)*

**Notes:** Overall more wood chip surface material needs to be added. There needs to be a minimum of 9 inches of material around the playground. I advise putting at least 12 inches of material in the playground.

Severity: Moderate (marginal impact)

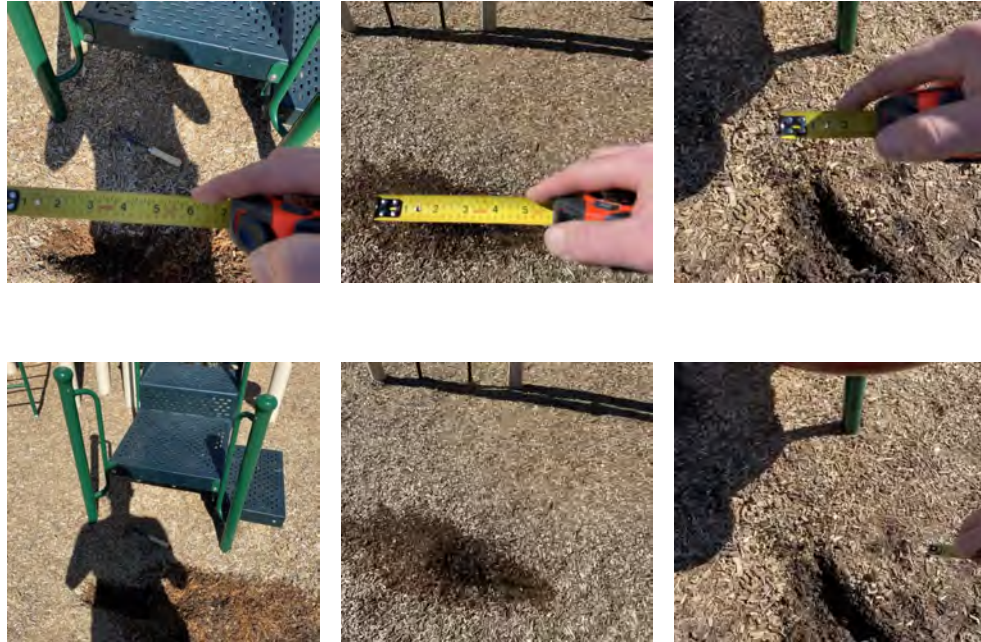
Positive Finding Loose-fill surfacing materials have no foreign objects or debris  
**Issue Identified** **Loose-fill surfacing materials were displaced under heavy use areas**  
**Recommendation** *Replace the surfacing material. [reference ASTM I 1487, CPSC] [View ASTM Site](#)*

**Notes:** There is a lot of displacement of surface material. Someone should come out at least weekly to make sure surface material has not been displaced.

Severity: Low (minor impact)

Can you request this service from your landscaping company?

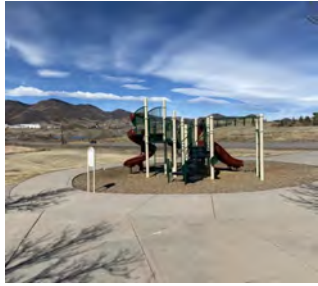
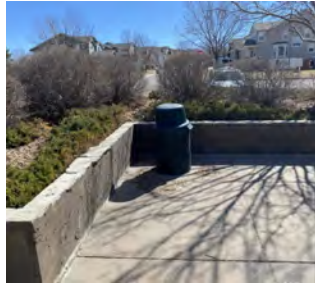
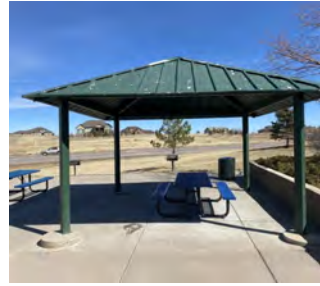
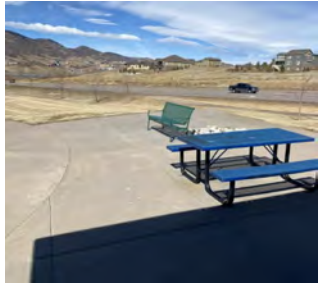
Positive Finding The entire play area has satisfactory drainage

Positive Finding There are no user modifications to the equipment

Positive Finding The entire playground is free from debris and litter

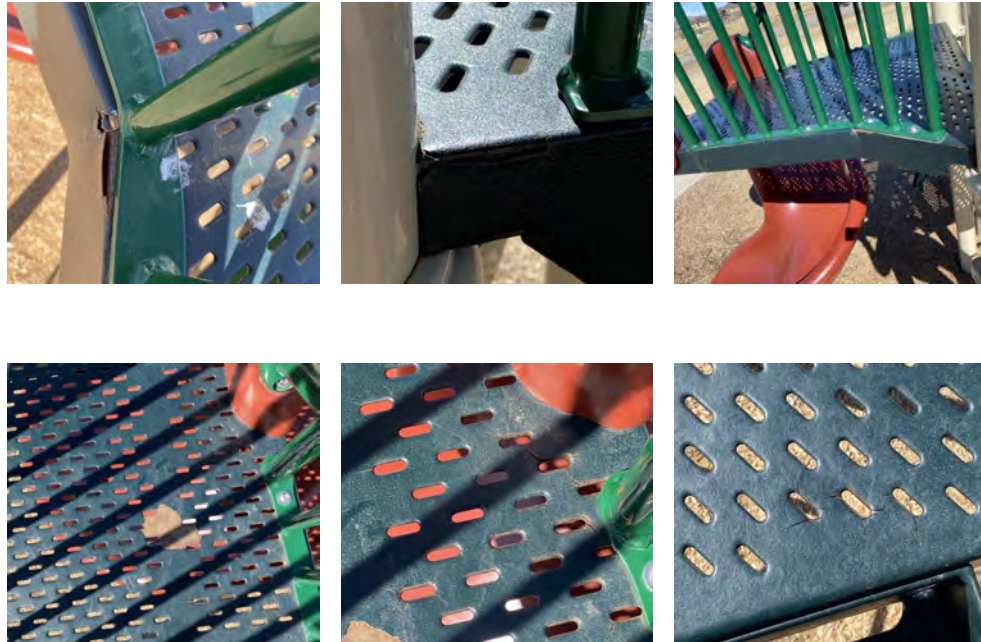
**There are broken or cracked pieces on the equipment**

**Notes:** Platform in front of stairs is on its last leg and will need to be replaced soon. There is rust spots from the coating cracking and breaking. There is also an area missing the coating causing exposed metal.

Severity: Low (minor impact)

*Repair and or replace broken or cracked pieces on the equipment. [reference ASTM 1487, CPSC] [View ASTM Site](#)*

Look into replacement or trying to have it Re coated

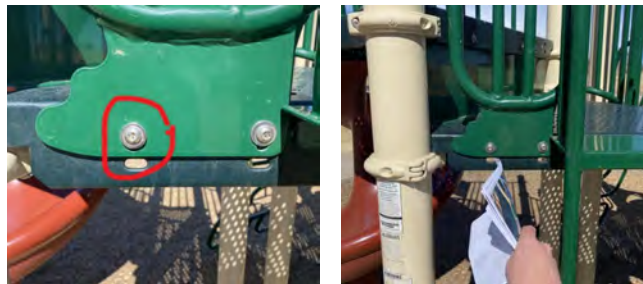
**Issue Identified** There are loose, missing bolts or nuts on the equipment

**Notes:** Tighten loose bolt. This is a repeat from the last inspection.

Severity: Moderate (marginal impact)

**Recommendation** Replace and or tighten the nuts in accordance with manufactures instructions. [reference ASTM 1487, CPSC] [View ASTM Site](#)

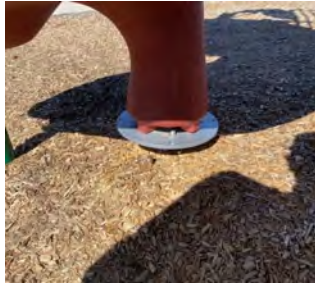
**Issue Identified** Worksite is not free from other recognized hazards

Severity: Advisory (negligible impact)

**Recommendation** Correct the unsafe conditions/hazards. [reference ASTM 1487, CPSC] [View ASTM Site](#)

**Notes:** Add enough material so that the baseplate is covered.
