Re: Roxborough - Community Park Safety Survey

Report Name: Roxborough - Community Park  
Completed for: Roxborough Village Metro  
Inspection Date: March 15, 2022  
Score: 0.0%

**Scope of Work:** Chatfield Farms Park

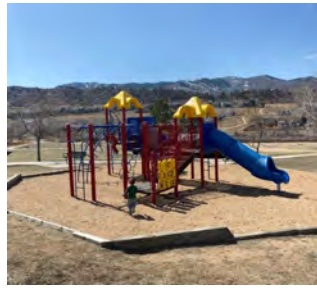
Positive Finding The entire play area has satisfactory drainage  
Positive Finding The entire playground is free from debris and litter  
**Issue Identified** **The signs used for play areas are not legible or are not in good repair**  
**Recommendation** *Maintain the signs in the park so they are legible and in good repair. [reference ASTM 1487, CPSC] [View ASTM Site](#)*

**Notes:** Add signage to the playground with park rules and appropriate age ranges.  
Severity: Low (minor impact)  
Contributing Factor: Administrative

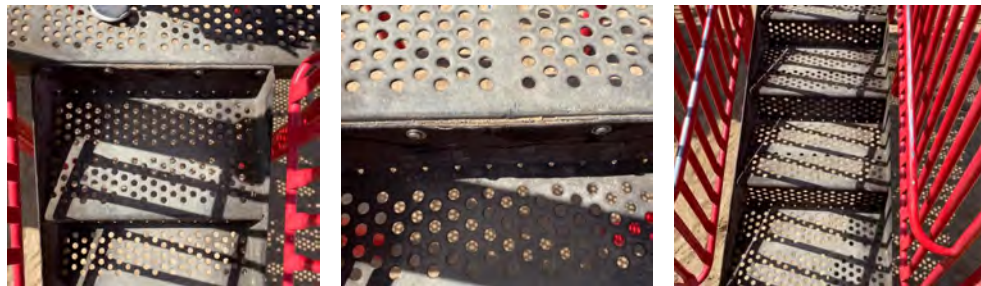
**Issue Identified** **There are broken or cracked pieces on the equipment**

**Notes:** There are cracks on the edge of the stairs. It is cause it to rust and could cut a child that falls on the edge. Coat the steps.

Severity: Moderate (marginal impact)

**Recommendation** *Repair and or replace broken or cracked pieces on the equipment. [reference ASTM 1487, CPSC] [View ASTM Site](#)*

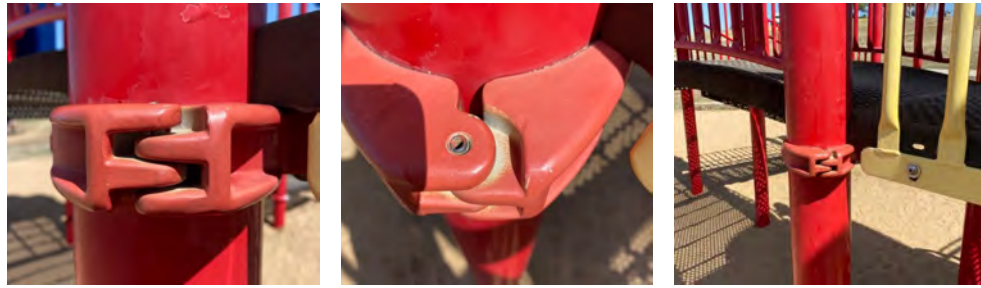
**Issue Identified** **There are broken or cracked pieces on the equipment**

**Notes:** The pin for the bracket is bending. I would replace it before it completely lets lose.

Severity: Low (minor impact)

**Recommendation** *Repair and or replace broken or cracked pieces on the equipment. [reference ASTM 1487, CPSC] [View ASTM Site](#)*

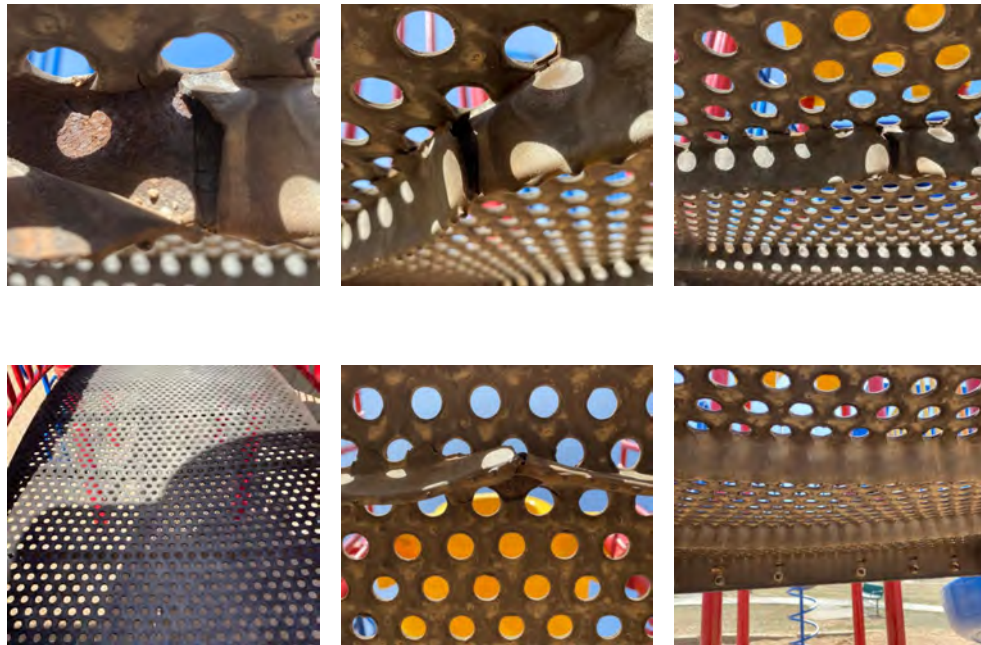
**Issue Identified** **There are broken or cracked pieces on the equipment**

**Notes:** The bridge needs some work. It is cracking in a few areas and it has a good size bow in the bridge. There is a large crack that is rusting the bridge. Get this fixed or addressed immediately.

Severity: Serious/Extreme (deducts 5%)

**Recommendation** *Repair and or replace broken or cracked pieces on the equipment. [reference ASTM 1487, CPSC] [View ASTM Site](#)*

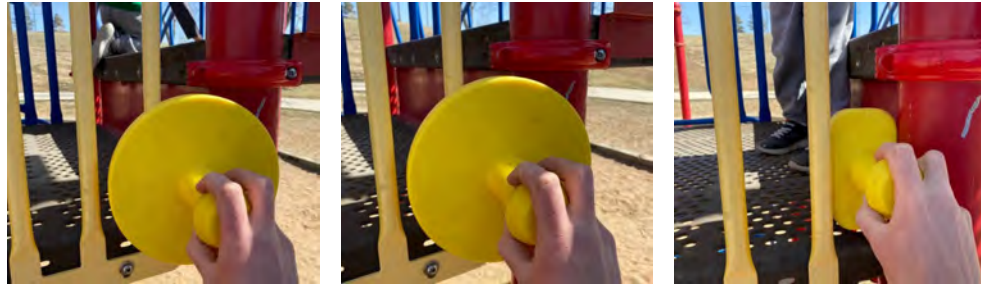
**Issue Identified** **There is an entanglement or head entrapment hazard**

**Notes:** There is a head entrapment hazard. If the small probe fits, than the larger probe must fit as well. The railing needs to be shifted over approximately 1/2 inch to be compliant.

This is the 3rd documented issue with this spot and it has not been addressed. If something happens at this location it will be considered negligent.

Severity: Critical/Catastrophic (deducts 10%)

**Recommendation** *Address the issues immediately. [ASTM 1487] [View ASTM Site](#)*

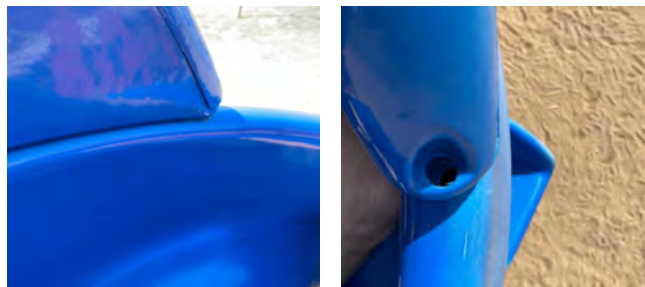
**Issue Identified** There are loose or missing bolts & nuts on the slides

**Notes:** Slide is missing a bolt. This is another reason why the slide is falling apart.

Severity: Serious/Extreme (deducts 5%)

**Recommendation** Replace and or tighten the nuts in accordance with manufactures instructions. [reference ASTM I 1487, CPSC] [View ASTM Site](#)

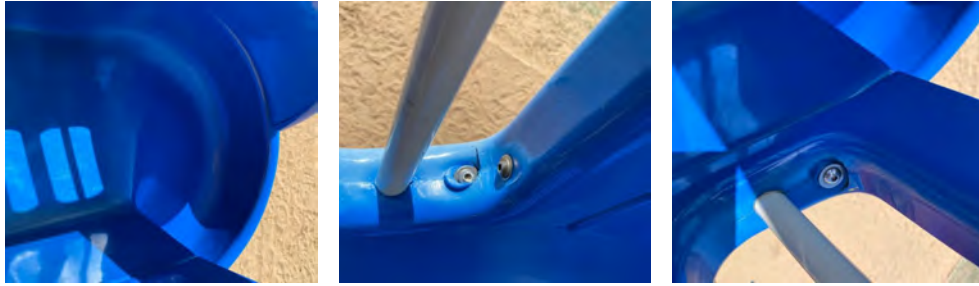
**Issue Identified** There are broken or cracked pieces or gaps on the slides

**Notes:** The whole slide and walkway needs to get replace ASAP. This is the 3rd time I have mentioned this issue. The whole platform is lose and it is only a matter of time before it completely falls apart.

Severity: Critical/Catastrophic (deducts 10%)

**Recommendation** Repair and or replace broken or cracked pieces on the equipment and correct the gap on the slide. [reference ASTM I 1487, CPSC] [View ASTM Site](#)

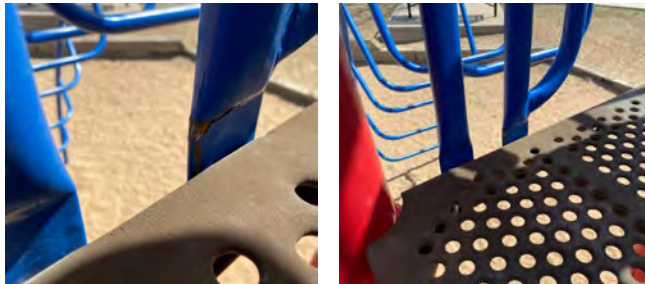
**Issue Identified** There are broken or cracked pieces on the equipment

**Notes:** The panel is cracking at the base  
Severity: Advisory (negligible impact)  
Contributing Factor: Equipment

**Recommendation** Repair and or replace broken or cracked pieces on the equipment. [reference ASTM 1487, CPSC] [View ASTM Site](#)

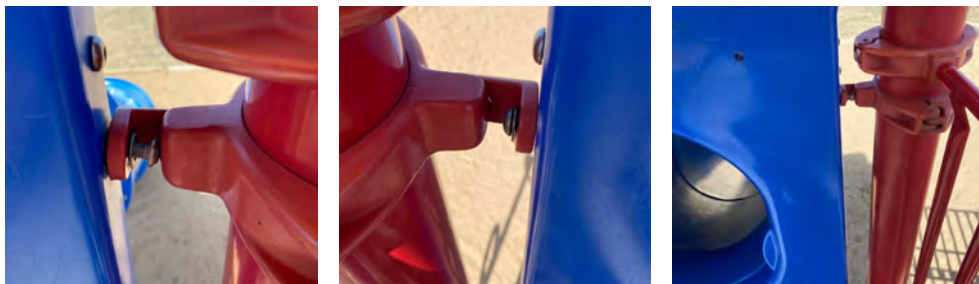
**Issue Identified** There are loose, missing bolts or nuts on the equipment

**Notes:** Lose bolts on both sides of the slide.  
Severity: Serious/Extreme (deducts 5%)  
Contributing Factor: Equipment

**Recommendation** Replace and or tighten the nuts in accordance with manufactures instructions. [reference ASTM 1487, CPSC] [View ASTM Site](#)
