**Colorado Special Districts
Property and Liability Pool**

Re: Roxborough - Crystal Lake Park Safety Survey

Report Name: Roxborough - Crystal Lake Park
Completed for: Roxborough Village Metro
Inspection Date: March 15, 2022
Score: 26.9%

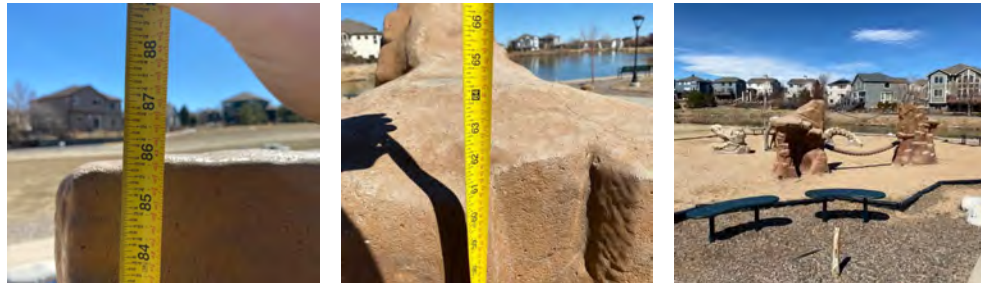
Issue Identified **Protective surfacing under and around the equipment is not adequate**
Recommendation *Install/replace surfacing materials. [reference ASTM I 1487, CPSC] [View ASTM Site](#)*

Notes: The height of this play area is 64 plus inches. For this height there should be wood chips as surface material at a minimum. Anything over 4 feet needs to have wood mulch or wood chips at a minimum.

Severity: Moderate (marginal impact)

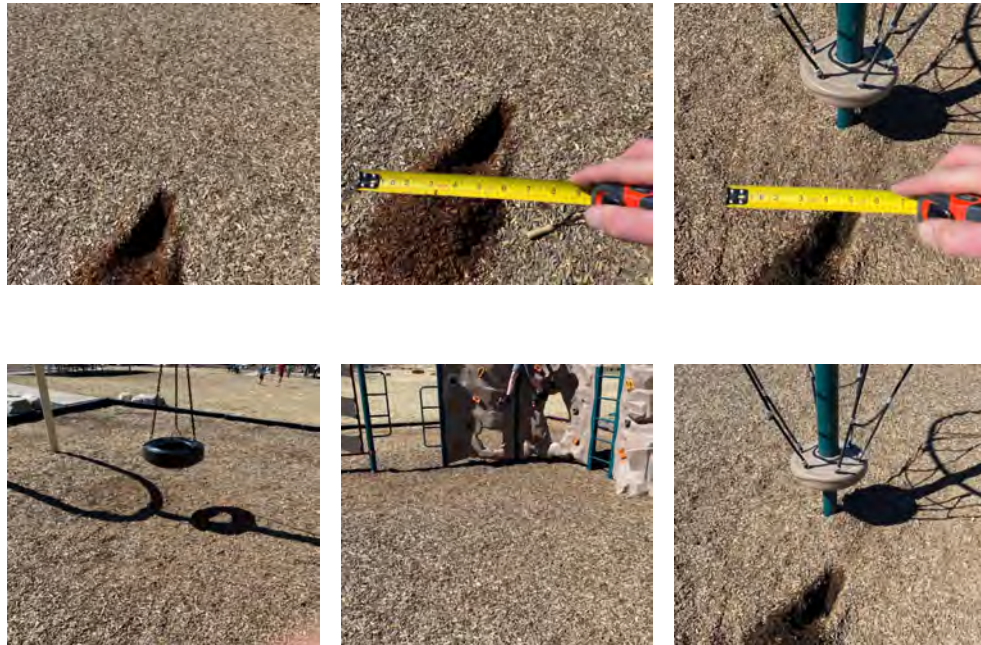
Issue Identified **There is not 9 inches of surface material**
Recommendation *Ensure that there is minimum of 9 inches of surface material. It is recommended that you add enough material to have 12 inches of material so that there is 9 inches after compaction and after material is pushed around. [ASTM F1292] [View ASTM Site](#)*

Notes: There is not quite enough material in this area. There needs to be at least 9 inches of material. Because you do not have someone maintaining the playground weekly you should put a total of 12 inches of material in all areas.

Severity: Moderate (marginal impact)

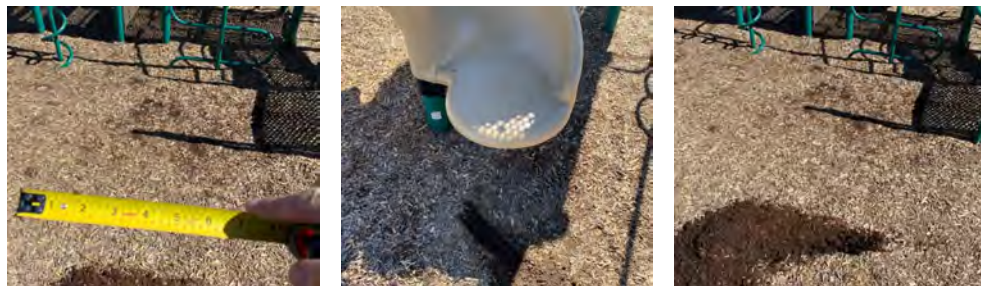
Issue Identified **There is not 9 inches of surface material**

Notes: More surface material needs to be added to the main playground. Ensure there is a total of 12 inches of material to allow for displacement and compaction.

Severity: Moderate (marginal impact)

Recommendation *Ensure that there is minimum of 9 inches of surface material. It is recommended that you add enough material to have 12 inches of material so that there is 9 inches after compaction and after material is pushed around. [ASTM F1292] [View ASTM Site](#)*

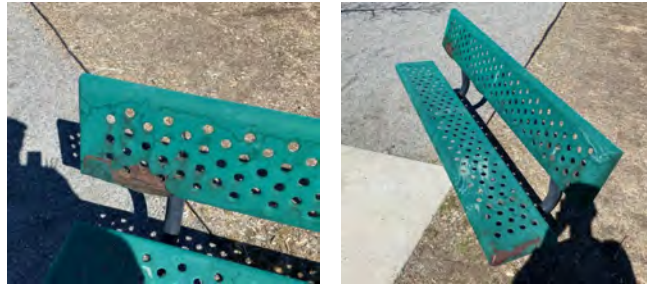
Issue Identified **There are damaged fences, benches, or signs on the playground**

Notes: The benches have seen better days. Start thinking about re-coating the benches so they stay in good condition.

Severity: Advisory (negligible impact)

Recommendation *Repair/replace damaged fences, benches, or signs on the playground. [reference ASTM 1487, CPSC] [View ASTM Site](#)*

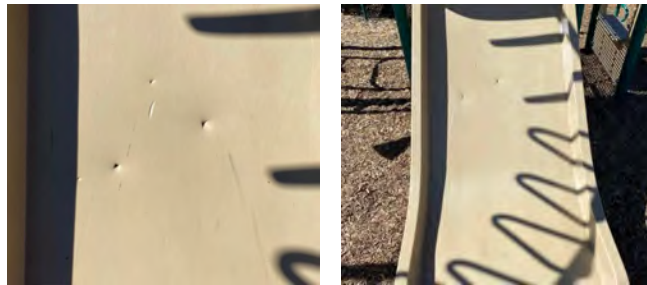
Issue Identified **Evidence of vandalism present**

Notes: The slide looks like it was stabbed with something. Monitor it to make sure it does not get worse.

Severity: Advisory (negligible impact)

Recommendation *Mitigate all evidence of vandalism. [reference ASTM 1487, CPSC] [View ASTM Site](#)*

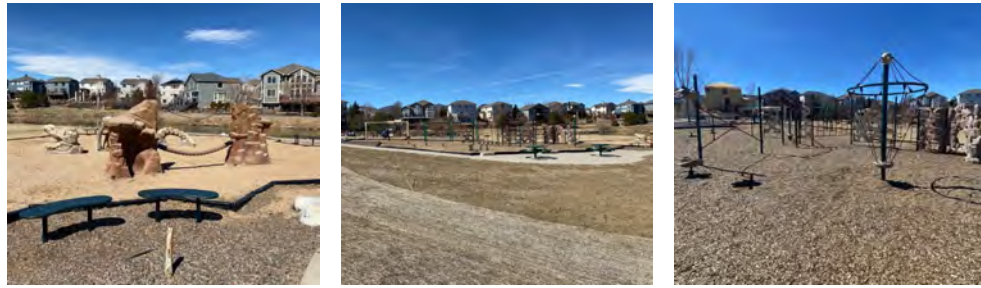
Issue Identified **The signs used for play areas are not legible or are not in good repair**

Notes: The playground is missing signage with rules and age ranges for the different structures.

Severity: Low (minor impact)

Recommendation *Maintain the signs in the park so they are legible and in good repair. [reference ASTM 1487, CPSC] [View ASTM Site](#)*

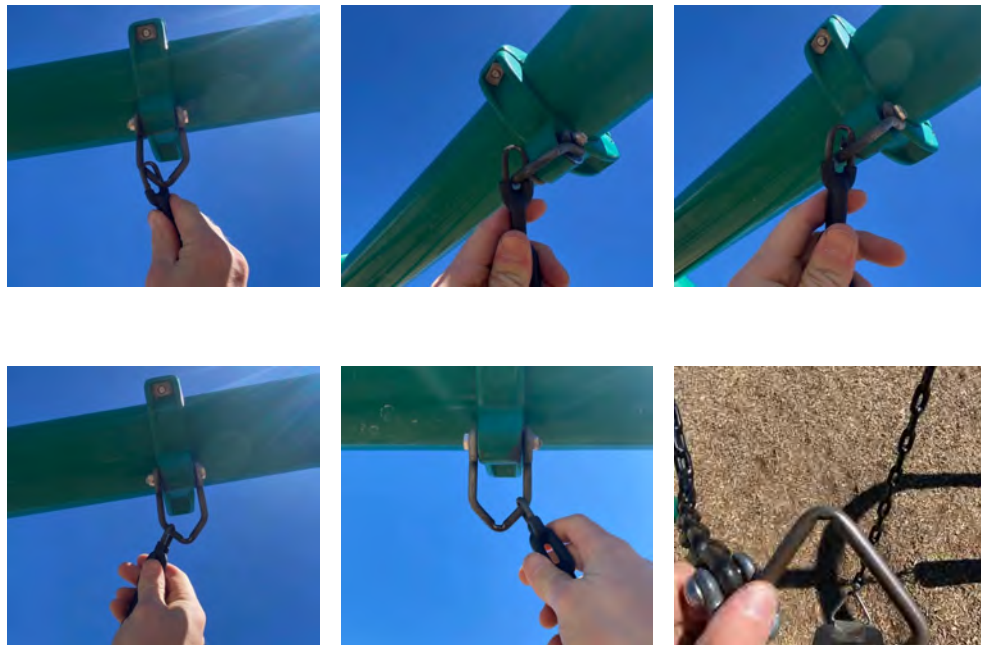
Issue Identified The swing chains are not in good condition

Notes: The swing set chains and brackets are all in VERY poor condition and need to be replaced. 10% of wear is allowed and these swings are more on the 50% of wear. It is only a matter of time before the break.

Severity: Serious/Extreme (deducts 5%)

Recommendation Replace or repair the swing chains. [reference ASTM 1487, CPSC] [View ASTM Site](#)

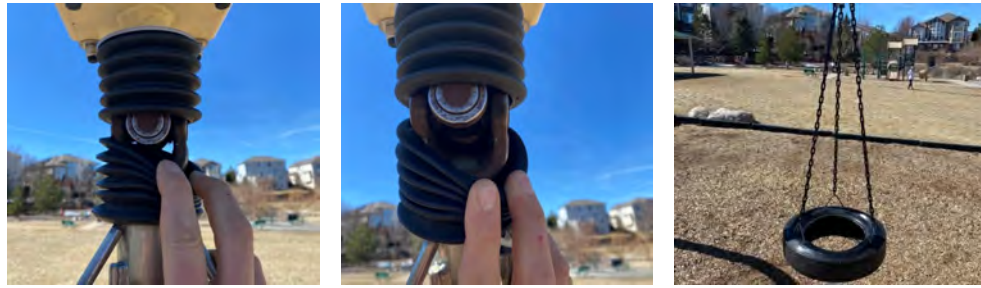
Issue Identified The swing chains are not in good condition

Notes: The top of the tire swing has a broken protective cover. It is split in half. Replace this so that someone does not get a finger smashed.

Severity: Moderate (marginal impact)

Recommendation Replace or repair the swing chains. [reference ASTM 1487, CPSC] [View ASTM Site](#)

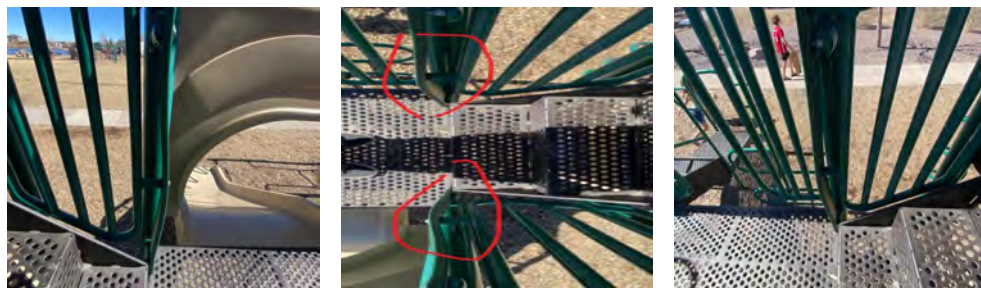
- Positive Finding There are no obstructions in the playground use zone
- Positive Finding There are proper guardrails on the structures
- Issue Identified** **There are broken or cracked pieces on the equipment**
- Recommendation** *Repair and or replace broken or cracked pieces on the equipment. [reference ASTM 1487, CPSC] [View ASTM Site](#)*

Notes: The whole side of the playground seems to have shifted causing supports to bend. I am not sure on a solution but i would call in a professional or reach out to the company that installed the playground. It may have been installed incorrectly.

Severity: Serious/Extreme (deducts 5%)
 Contributing Factor: Equipment

The playground seems to have shifted causing the supports to bend

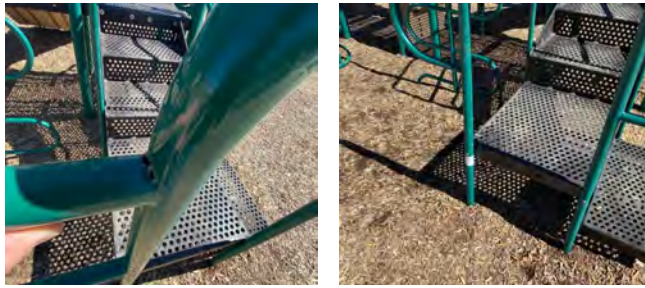
- Issue Identified** **There are broken or cracked pieces on the equipment**
- Recommendation** *Repair and or replace broken or cracked pieces on the equipment. [reference ASTM 1487, CPSC] [View ASTM Site](#)*

Notes: This handrail has an incomplete weld. This allows water to go inside and it can damage the playground from the inside out. I would try to get it replaced by the manufacturer.

Severity: Low (minor impact)
 Contributing Factor: Equipment

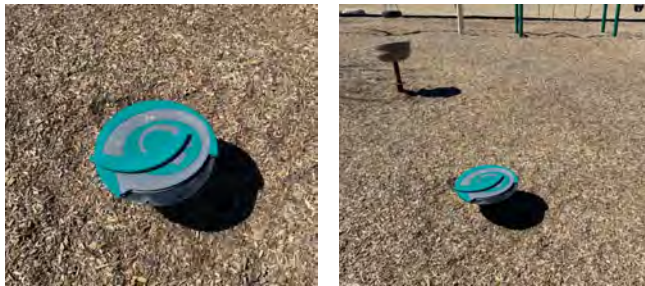
Issue Identified **There are broken or cracked pieces on the equipment**

Notes: The spinner is broken on the top and needs to be replaced.
Severity: Low (minor impact)
Contributing Factor: Equipment

Recommendation *Repair and or replace broken or cracked pieces on the equipment. [reference ASTM 1487, CPSC] [View ASTM Site](#)*

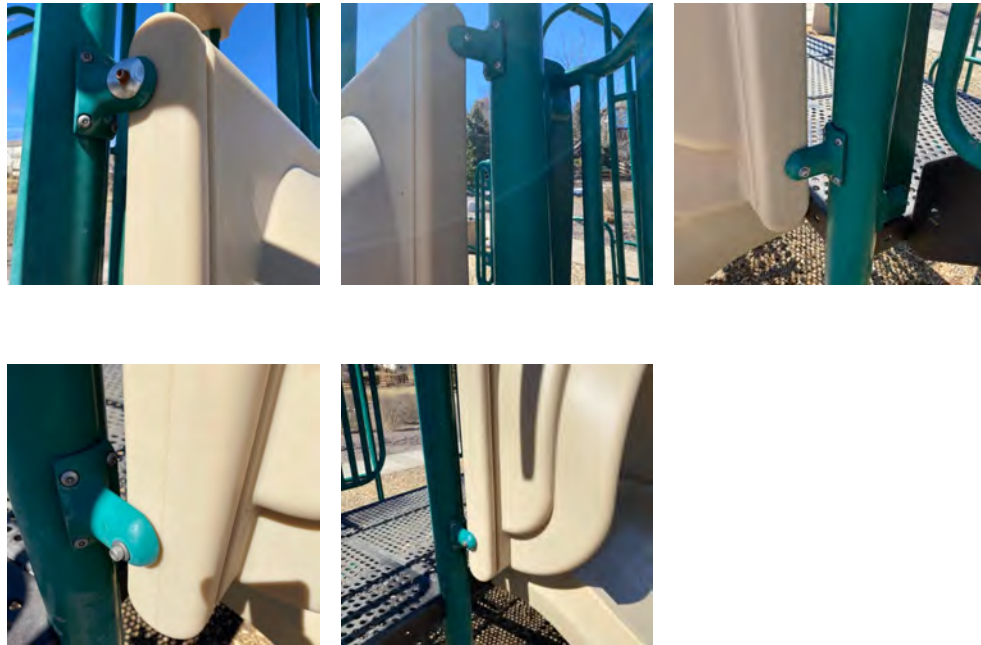
Issue Identified **There are protrusions on the structure**

Notes: Replace the bolts with the proper bolts. Proper screw/bolt is in the last picture.
Severity: Advisory (negligible impact)
Contributing Factor: Equipment

Recommendation *There are no protrusions on the structure (No more than two threads protruding). [reference ASTM 1487, CPSC] [View ASTM Site](#)*

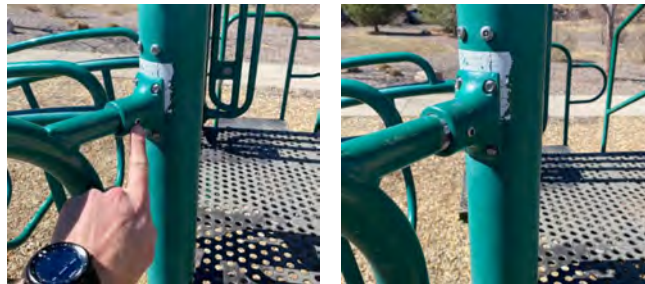
Issue Identified **There are loose, missing bolts or nuts on the equipment**

Notes: Lose screw on the main play structure.

Severity: Low (minor impact)

Recommendation *Replace and or tighten the nuts in accordance with manufactures instructions. [reference ASTM I 1487, CPSC] [View ASTM Site](#)*

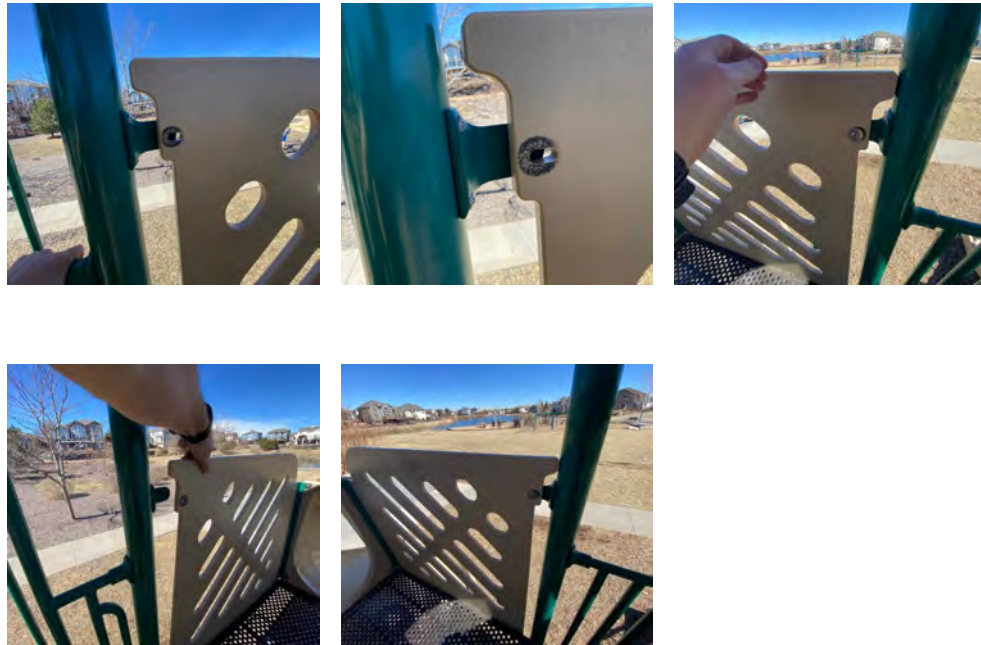
Issue Identified **There are loose, missing bolts or nuts on the equipment**

Notes: Bolt is missing completely and needs to be replaced with the correct manufacturer bolts.

Severity: Serious/Extreme (deducts 5%)

Recommendation *Replace and or tighten the nuts in accordance with manufactures instructions. [reference ASTM I 1487, CPSC] [View ASTM Site](#)*

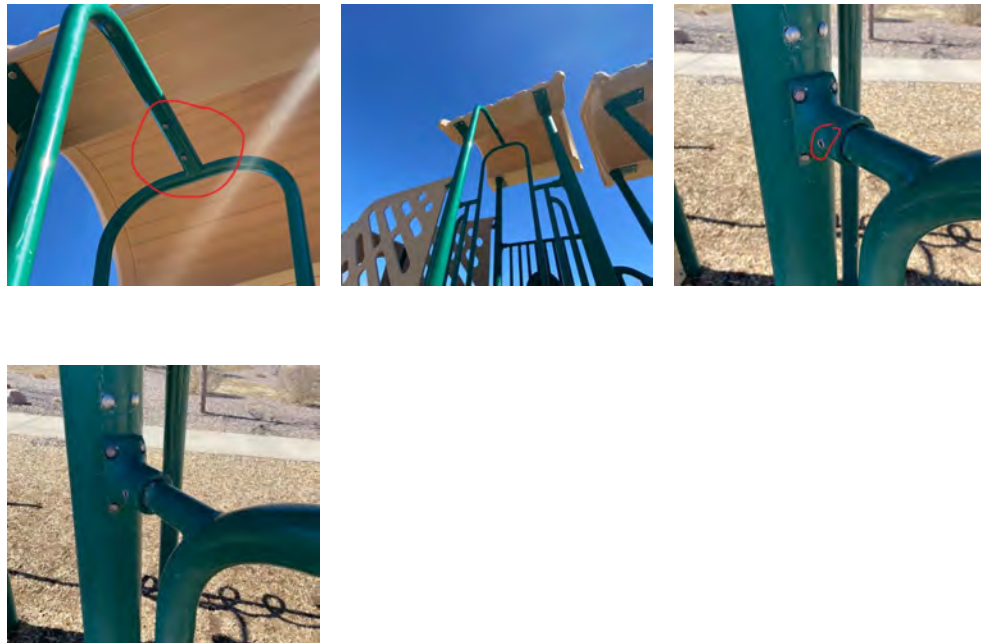
Issue Identified There are loose, missing bolts or nuts on the equipment

Notes: Lose screw
Severity: Low (minor impact)
Contributing Factor: Equipment

Recommendation Replace and or tighten the nuts in accordance with manufactures instructions. [reference ASTM 1487, CPSC] [View ASTM Site](#)

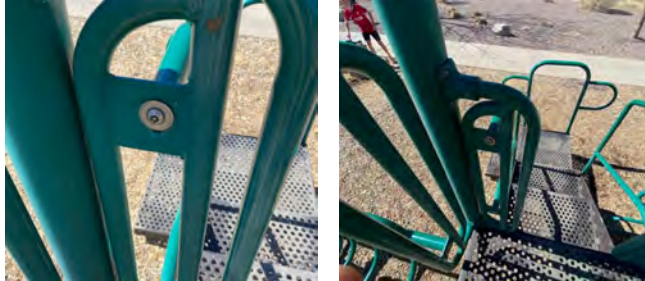
Issue Identified There are loose, missing bolts or nuts on the equipment

Notes: Lose bolt
Severity: Advisory (negligible impact)
Contributing Factor: Equipment

Recommendation *Replace and or tighten the nuts in accordance with manufactures instructions. [reference ASTM 1487, CPSC] [View ASTM Site](#)*

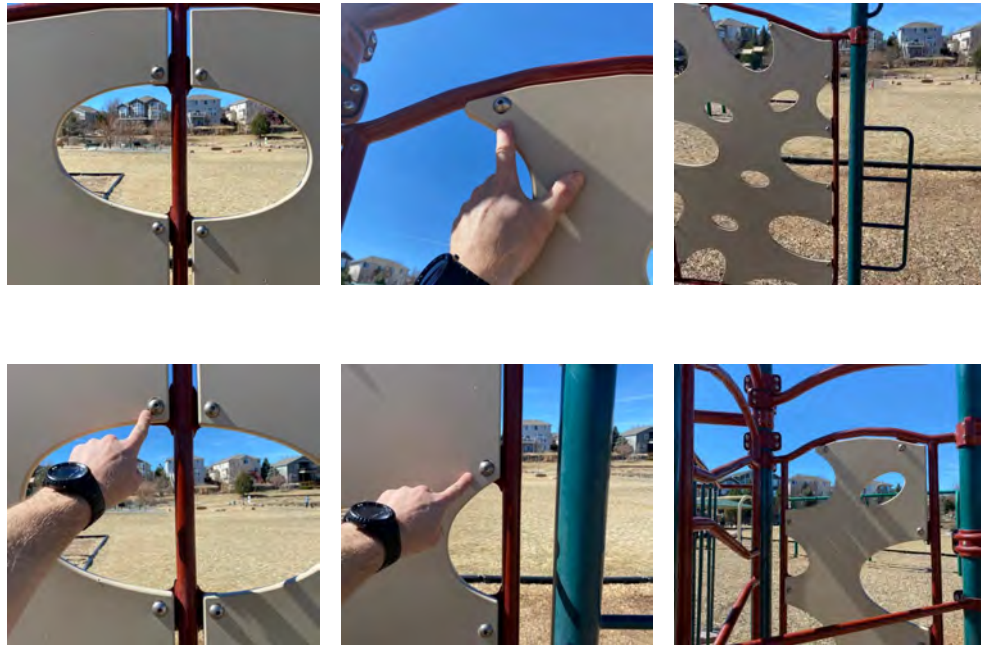
Issue Identified **There are loose, missing bolts or nuts on the equipment**

Notes: The entire structure needs to have the bolts tightened up. There are multiple lost bolts that you do not want to fall out.
Severity: Moderate (marginal impact)
Contributing Factor: Equipment

Recommendation *Replace and or tighten the nuts in accordance with manufactures instructions. [reference ASTM 1487, CPSC] [View ASTM Site](#)*
