April 13, 2022

Re: Roxborough Village - Liverpool And Cavaletti Park Safety Survey

Report Name: Roxborough Village - Liverpool And Cavaletti Park  
Completed for: Roxborough Village Metro  
Inspection Date: April 13, 2022  
Score: 64.7%

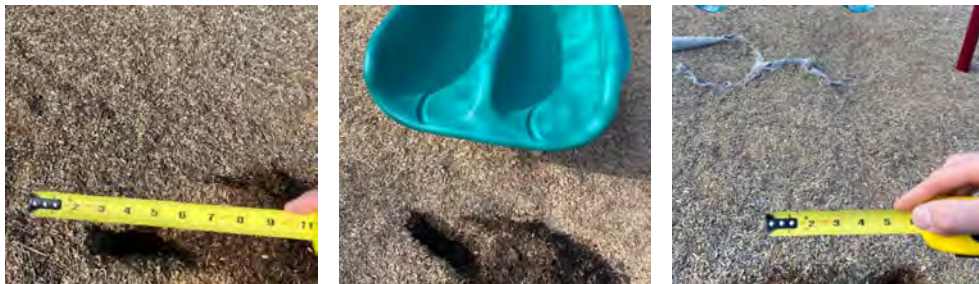
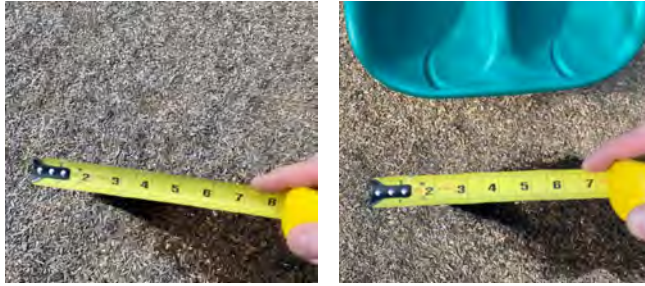
**Issue Identified** There is not 9 inches of surface material  
**Recommendation** Ensure that there is minimum of 9 inches of surface material. It is recommended that you add enough material to have 12 inches of material so that there is 9 inches after compaction and after material is pushed around. [ASTM F1292] [View ASTM Site](#)

**Notes:** There is not enough surface material at the playground.

Severity: Moderate (marginal impact)

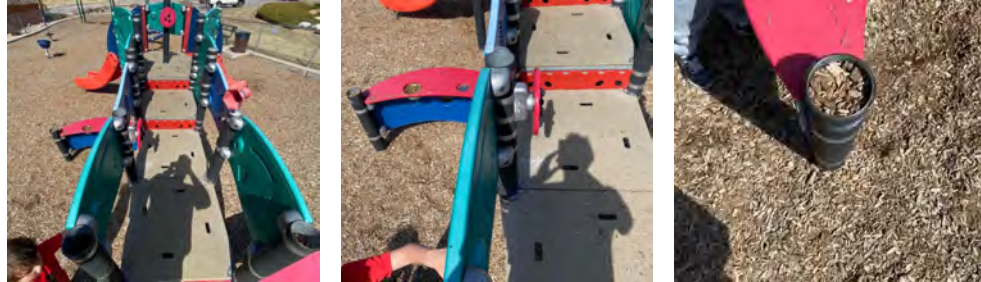
**Issue Identified** **There are broken or cracked pieces on the equipment**

**Notes:** There area lot of caps missing on the top of the support poles. They are filling up with wood chips and will cause the supports to start rusting from the inside out. This is the 2nd time I have mentioned this.

Severity: Moderate (marginal impact)

**Recommendation** *Repair and or replace broken or cracked pieces on the equipment. [reference ASTM 1487, CPSC] [View ASTM Site](#)*

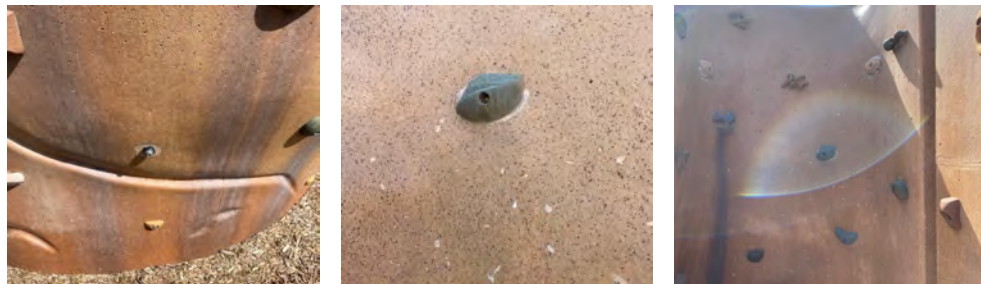
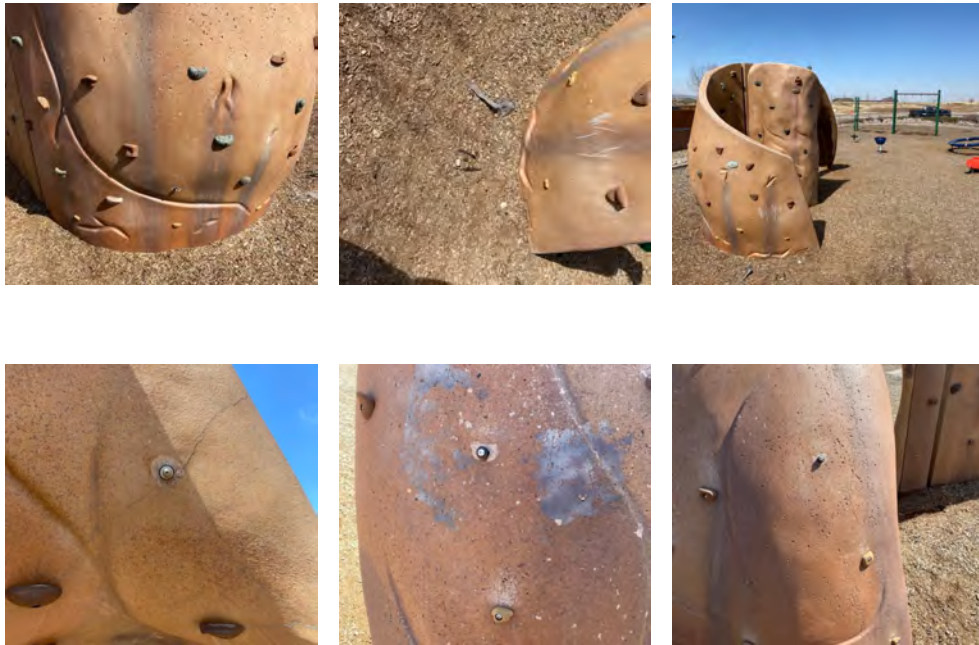
**Issue Identified** **There are loose, missing bolts or nuts on the equipment**

**Notes:** There are a lot of missing hand holds and even more lose hand holds on the climbing wall. Tighten everything up.

Severity: Moderate (marginal impact)

**Recommendation** *Replace and or tighten the nuts in accordance with manufactures instructions. [reference ASTM I 1487, CPSC] [View ASTM Site](#)*

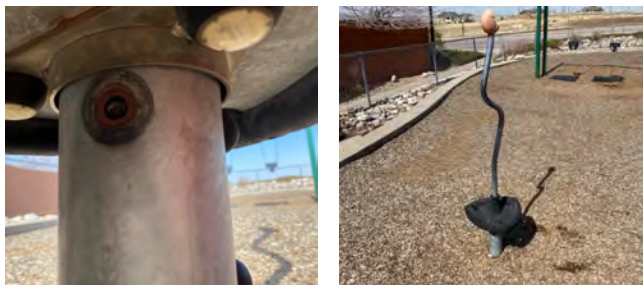
**Issue Identified** Worksite is not free from other recognized hazards

**Notes:** There is a broken bolt on the spinner. Replace bolt or remove the spinner.

Severity: Moderate (marginal impact)

**Recommendation** Correct the unsafe conditions/hazards. [reference ASTM 1487, CPSC] [View ASTM Site](#)
