Re: Roxborough - Marmot Ridge Park Safety Survey

Report Name: Roxborough - Marmot Ridge Park
Completed for: Roxborough Village Metro
Inspection Date: March 15, 2022
Score: 66.7%

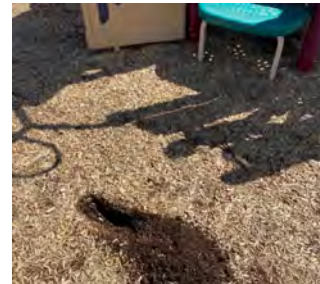
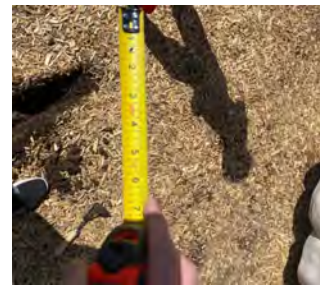
Issue Identified There is not 9 inches of surface material

Notes: There is not enough surface material. Make sure there is a total of 12 inches so that you can maintain at least 9 inches in all areas.

Severity: Moderate (marginal impact)

Recommendation Ensure that there is minimum of 9 inches of surface material. It is recommended that you add enough material to have 12 inches of material so that there is 9 inches after compaction and after material is pushed around. [ASTM F1292] [View ASTM Site](#)

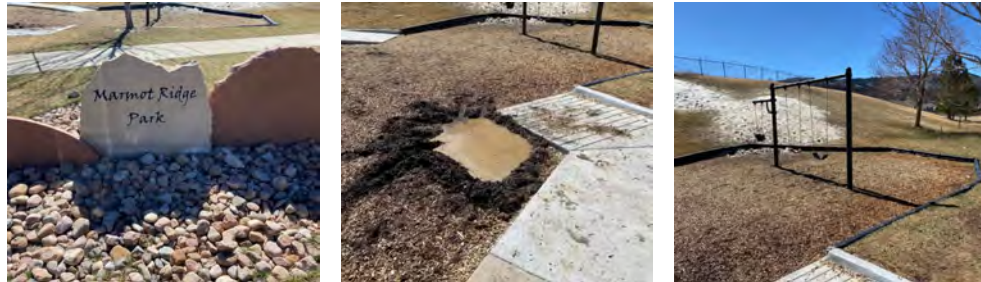
Issue Identified The entire play area did not have satisfactory drainage

Notes: The drainage looks to be an issue. Especially with all of the snow melt. Keep an eye on it during the summer but there may need to be some changes to the drainage.

Severity: Low (minor impact)

Recommendation *Improve drainage, especially in heavy use areas such as under swings and at slide exits. [reference ASTM 1487, CPSC] [View ASTM Site](#)*

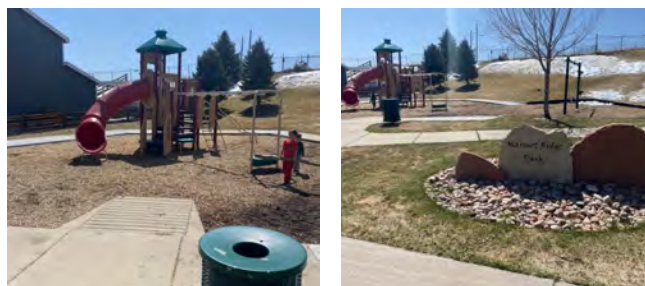
The signs used for play areas are not legible or are not in good repair

Notes: There is no playground signage for the park

Severity: Low (minor impact)

Maintain the signs in the park so they are legible and in good repair. [reference ASTM 1487, CPSC] [View ASTM Site](#)
