Re: Roxborough - Imperial Park Safety Survey

Report Name: Roxborough - Imperial Park  
Completed for: Roxborough Village Metro  
Inspection Date: March 15, 2022  
Score: 25.0%

**Scope of Work:** Chatfield Farms Park

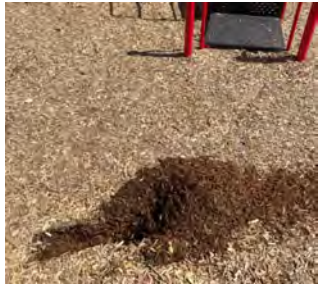
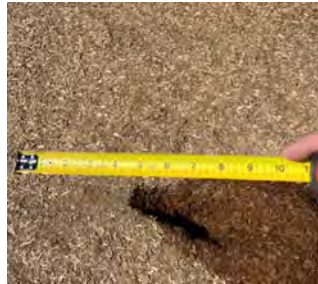
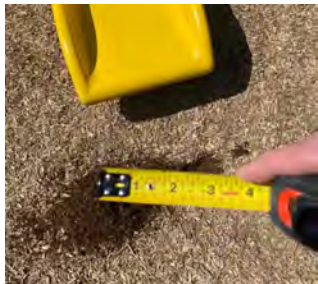
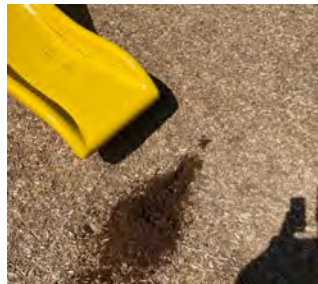
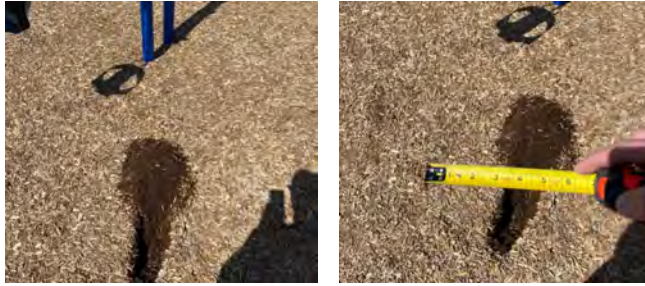
**Issue Identified** **There is not 9 inches of surface material**

**Notes:** In the non used area there is about 10 inches. Everywhere else there is not enough surface material. Add more material and rake it around so that you have 12 inches of material. This will ensure you have the minimum of 9 inches at all times.

Severity: Low (minor impact)

**Recommendation** *Ensure that there is minimum of 9 inches of surface material. It is recommended that you add enough material to have 12 inches of material so that there is 9 inches after compaction and after material is pushed around. [ASTM F1292] [View ASTM Site](#)*

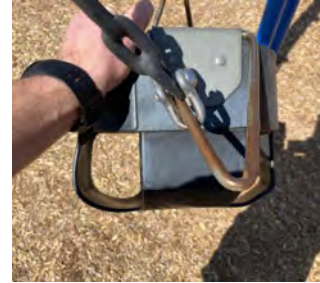
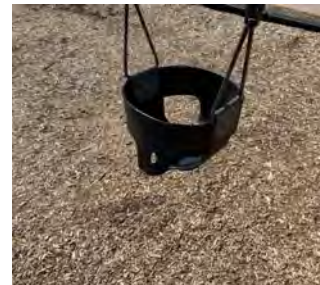
**Issue Identified** The swing seats are not in good condition

**Notes:** Replace the swing bucket. this is the 2nd time I have mentioned this in an audit.

Severity: Moderate (marginal impact)

**Recommendation** Replace or repair the swing seats. [reference ASTM 1487, CPSC] [View ASTM Site](#)

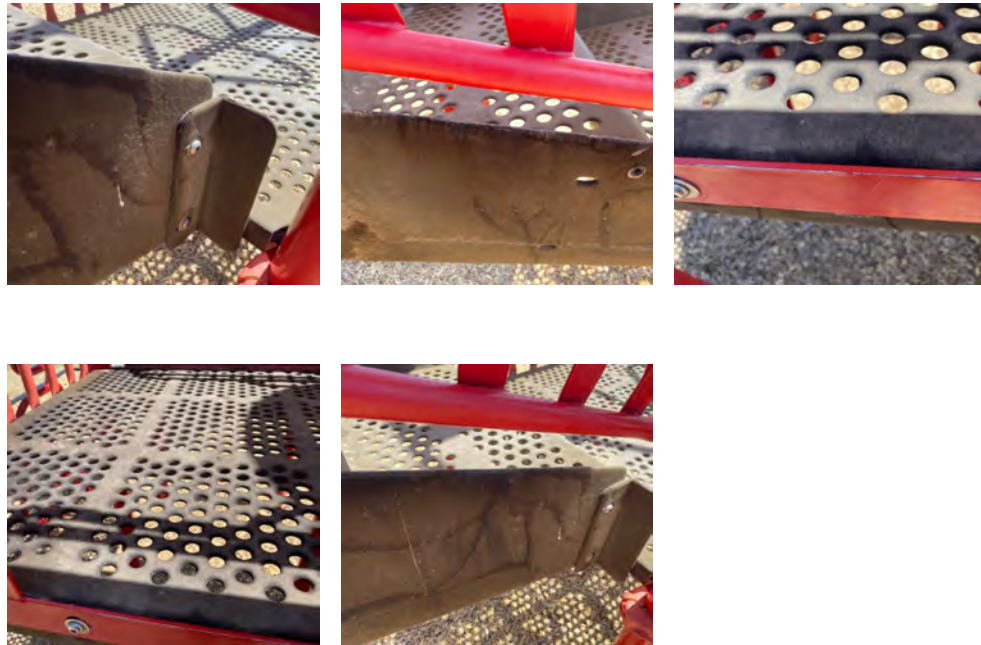
**Issue Identified** There are broken or cracked pieces on the equipment

**Notes:** The coating on the platforms is cracking everywhere. When it get a little worse it will be time to replace the structure or try to re-coat everything.

Severity: Advisory (negligible impact)

**Recommendation** Repair and or replace broken or cracked pieces on the equipment. [reference ASTM 1487, CPSC] [View ASTM Site](#)

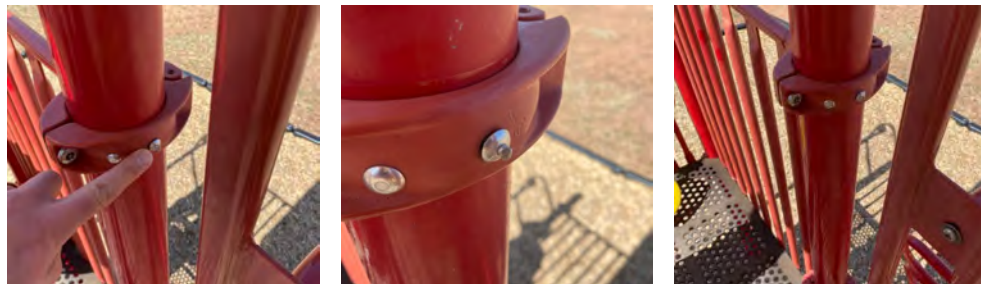
**Issue Identified** **There is an entanglement or head entrapment hazard**  
**Recommendation** *Address the issues immediately. [ASTMI 1487] [View ASTM Site](#)*

**Notes:** Cut down the rivet a little bit so that it does not snag a kids clothing.  
 Severity: Low (minor impact)  
 Contributing Factor: Equipment
